CAA Inspection Report

Inspection Date(s): July 17, 2018

Facility Name: Tallaboa Industrial Park

Asbestos NESHAP – 40 CFR 61 Subpart M

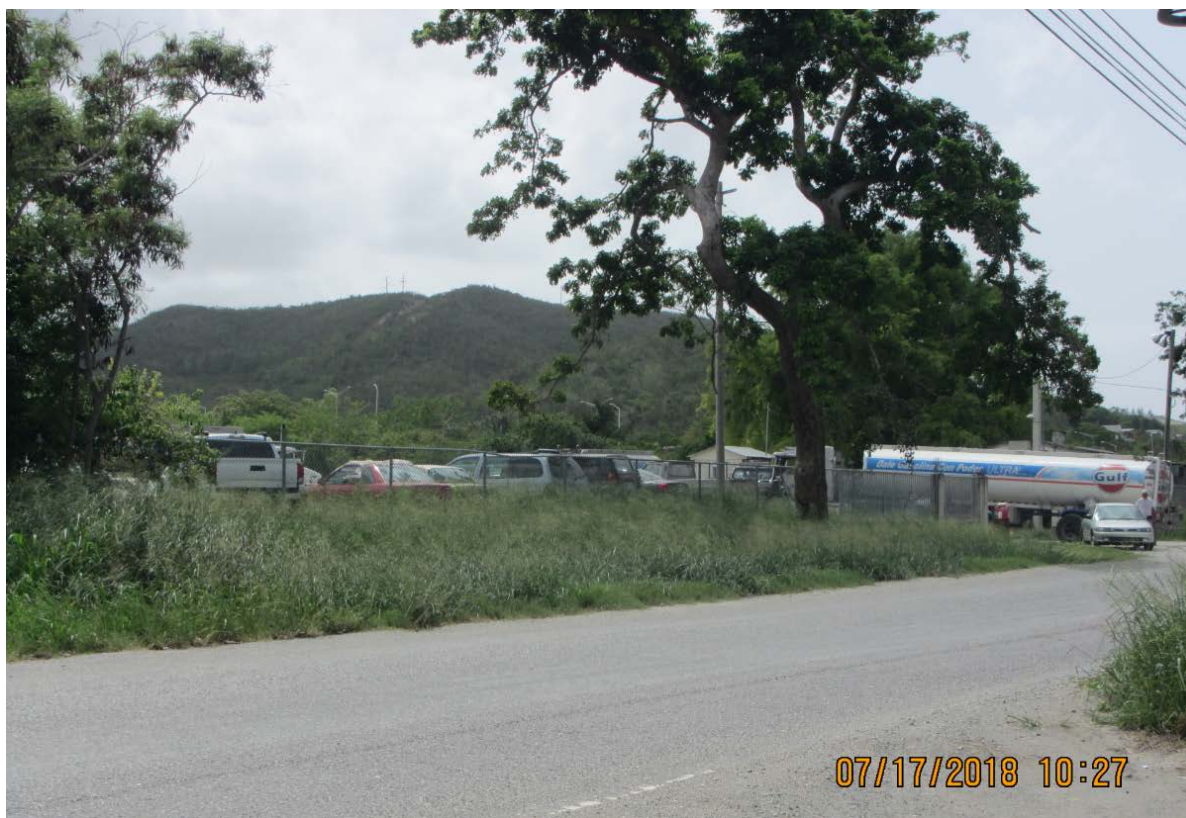
Figure 1, Parking lot directly south of the fence line of the Tallaboa Industrial Park Site.

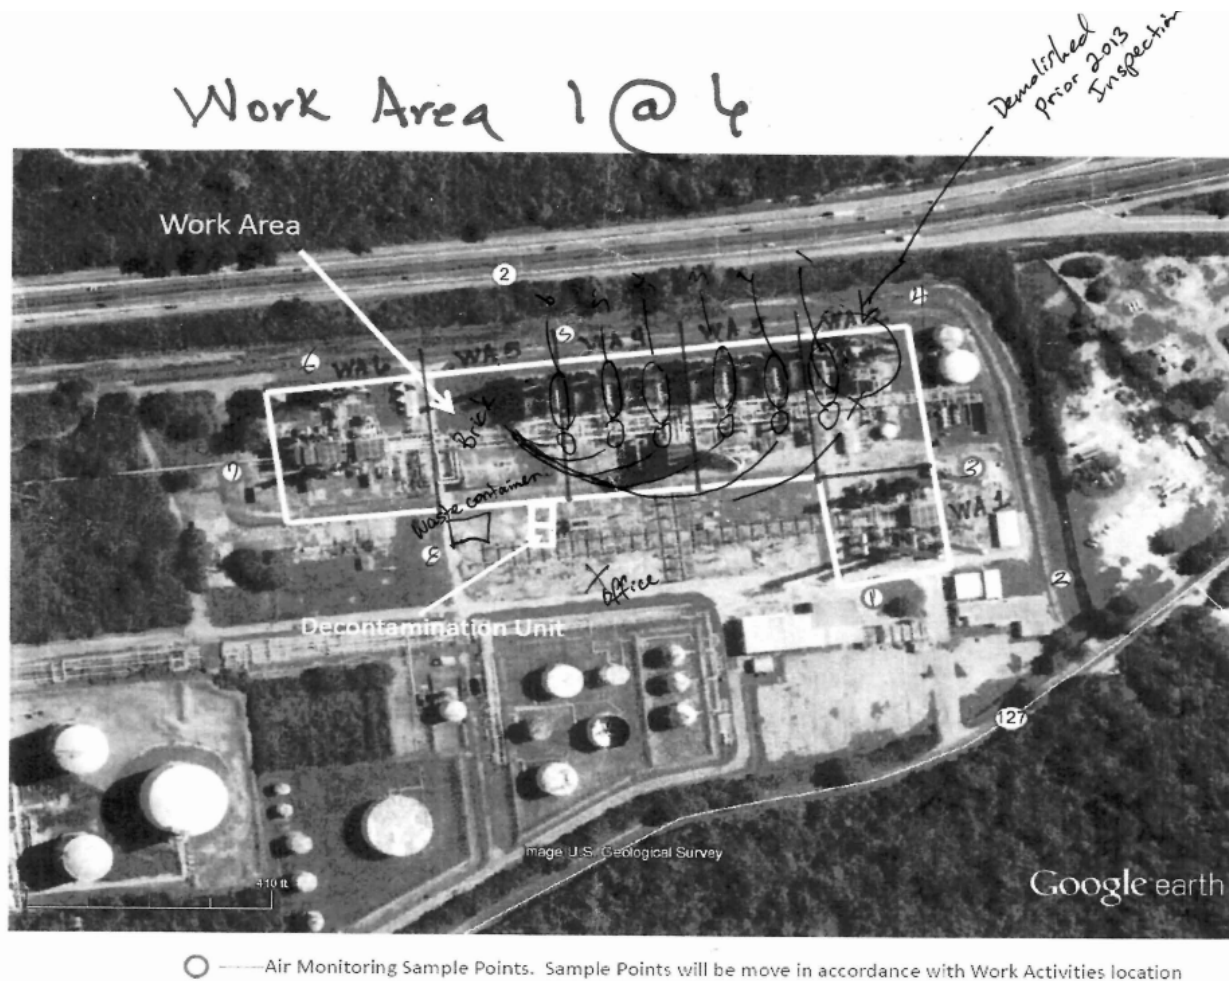
Homeca representatives escorted the inspector to the office that was setup in the middle of the TIP site. (See figure 2) The road to the site was not paved nor was there any sign of wetting to reduce dust plumes from vehicle activities. Inspector saw trucks driving into the site when he was getting out of his car. It appears that every time the truck breaks, a 4-6 feet dust plume is generated. Mr. Ramos confirmed during the in-brief that there is no wetting of the roads into the site and the dust plume is a result of the activation of the air brakes on those trucks.

Figure 2, Site map with inspector's notes

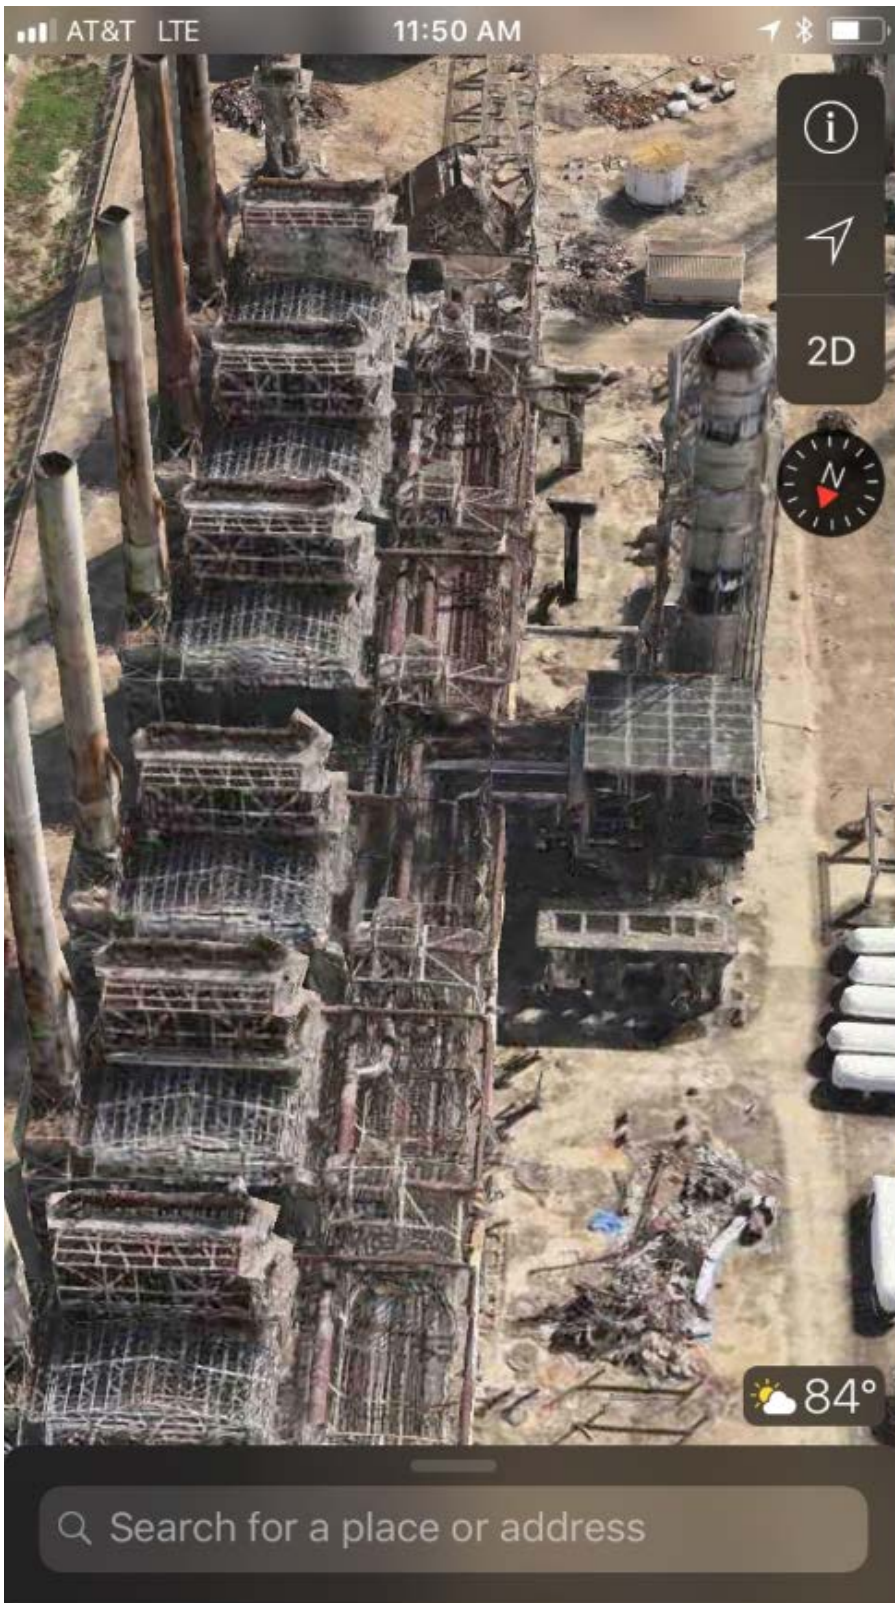
Figure 3, Image of TIP site prior to Homeca starting work in 2013

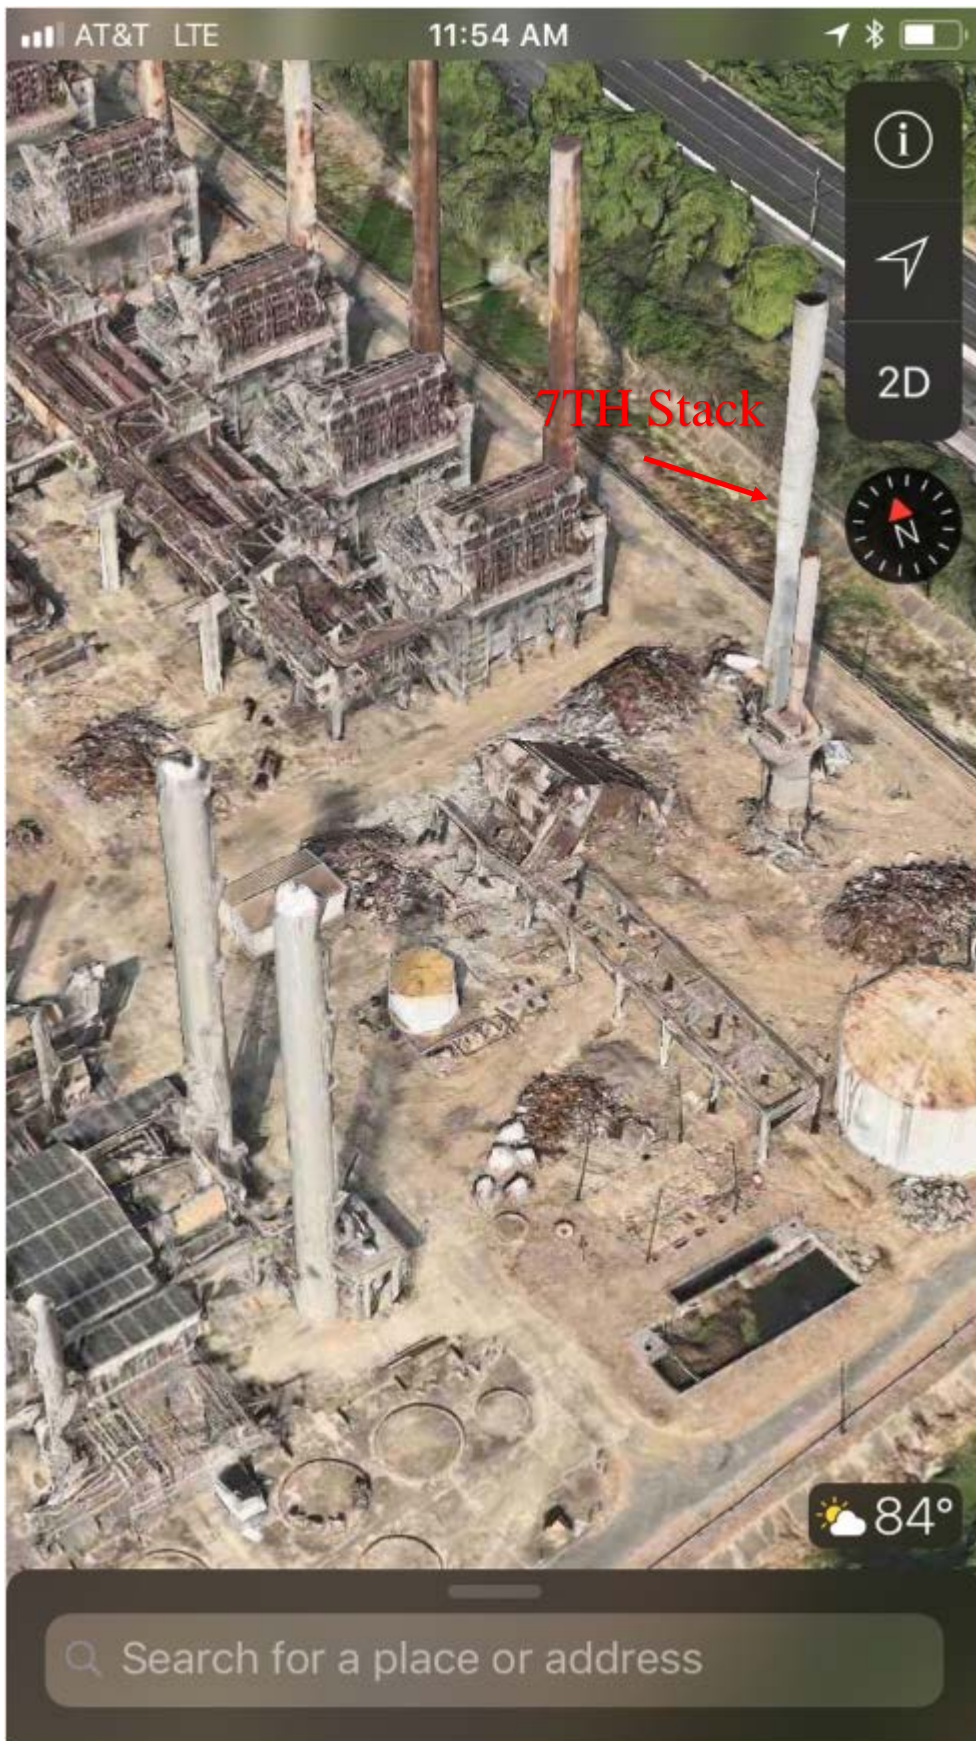
Figure 4, Image of TIP site prior to Homeca starting work in 2013 – Seventh smoke stack was still standing

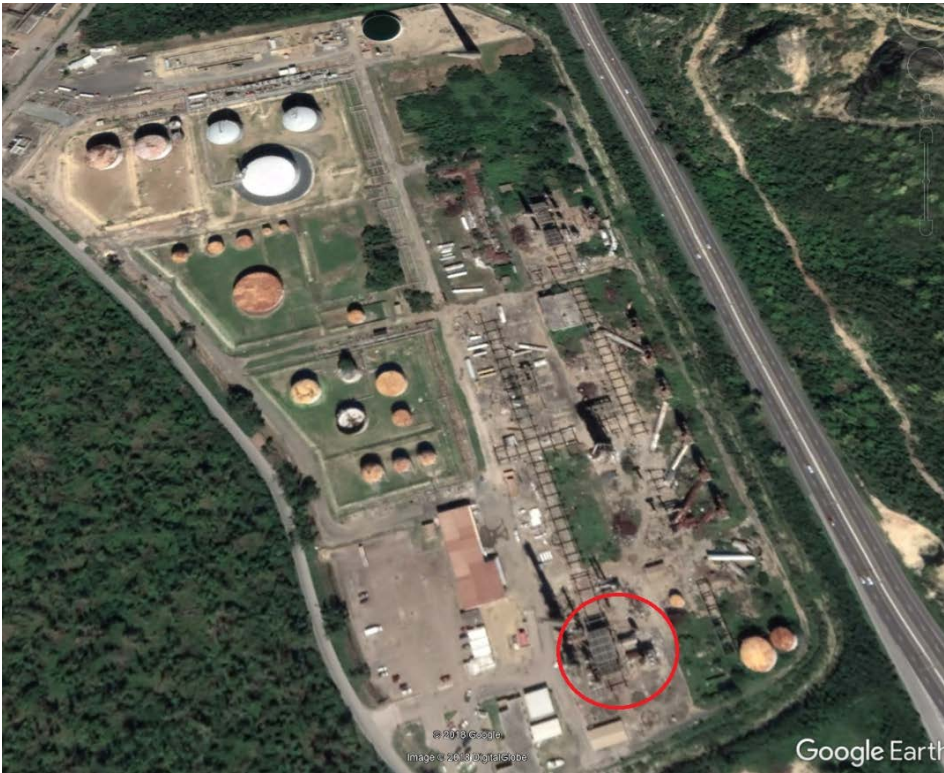
The inspector continued heading south of the Homeca work site (See figure 9). Comparing photo provided by Mr. Ramos which shows the site before Homeca started work in 2011 (figure 3 and 4), to the picture taken

Figure 9, Southern most location of work area. (see fig 7)

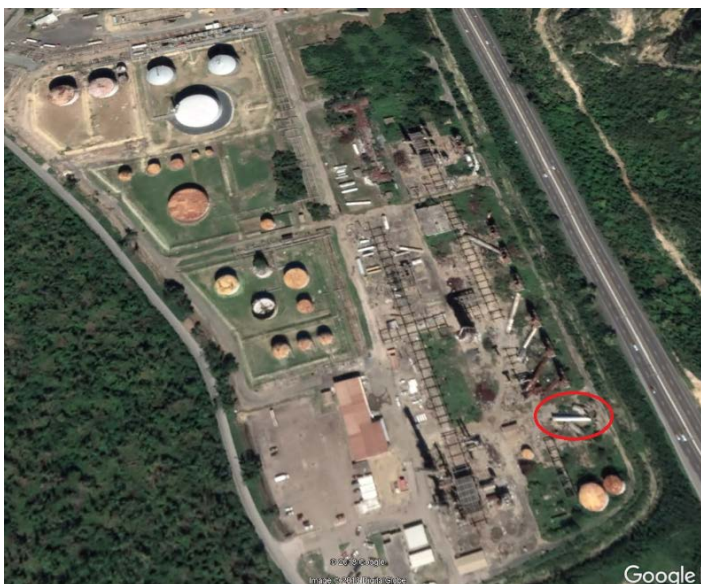
The inspector continued heading north-east (see figure 18). This is the location where, according to Homeca, a boiler was removed prior to Homeca taking the job. The stack was demolished by Homeca. The brick and non-metal debris remains on site and is located in close proximity to where it was removed from, near the corresponding stacks (see figure 19). The debris appears to be dry with no indication that there was any attempt made to keep it wet at all times, i.e. no water hose or water misters found. Figure 20 provides a better look of the liner inside the stack that Homeca did not test prior to demolishing the stacks.

Figure 18, Location where boiler was demolished prior to Homeca taking the job. The stack was not demolished prior Homeca taking the job (see fig 3).

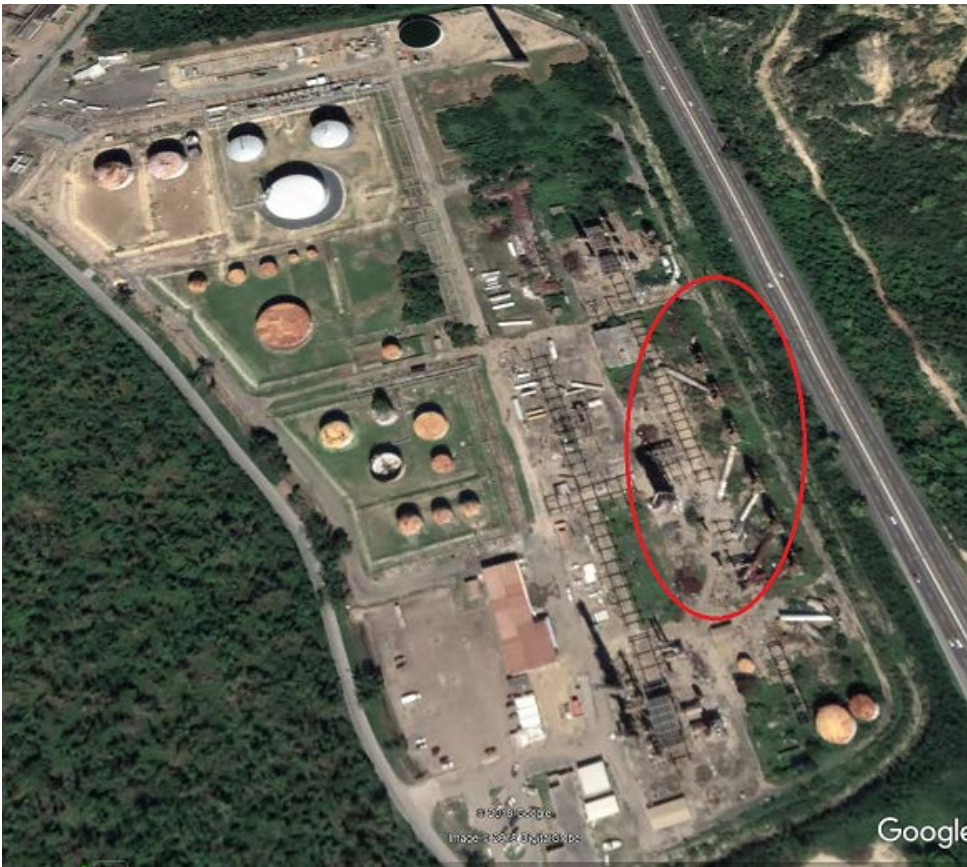
Figure 21, Location where 6 boilers were demolished by Homeca as part of the original job.

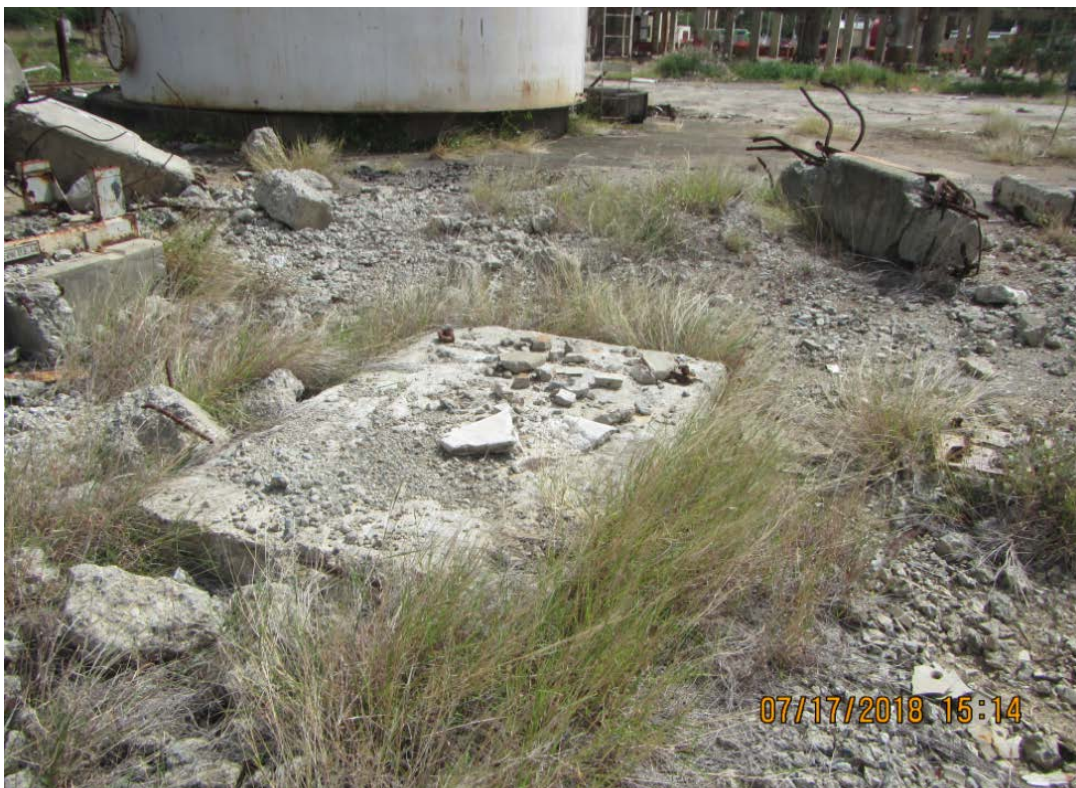
Figure 25, Zoom out of figure 23.

Insulation material were found in very poor conditions on and in the demolition debris (see figure 23). Insulation material are being found scattered throughout the work area (see figure 24 to 27). The 7 stacks that were demolished by Homeca have been crushed, cut and one case have been cut into numerous smaller pieces (see figure 28 to 30).

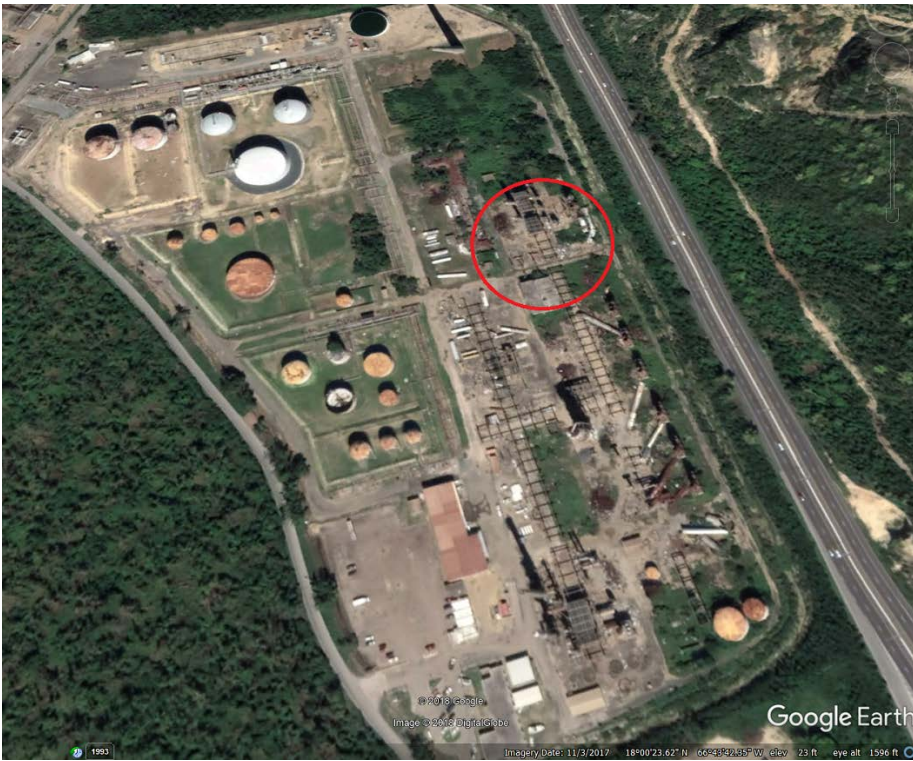
The inspector continued moving to the northern end of the Homeca work area (see figure 32). A large pile of metal was noted in front of the structures that were still standing. In and around the metal pile was insulation material that was readily identifiable (see figure 33 to 35). There is no indication of any wetting of the material.

Figure 32, Northern end of the Homeca work area.

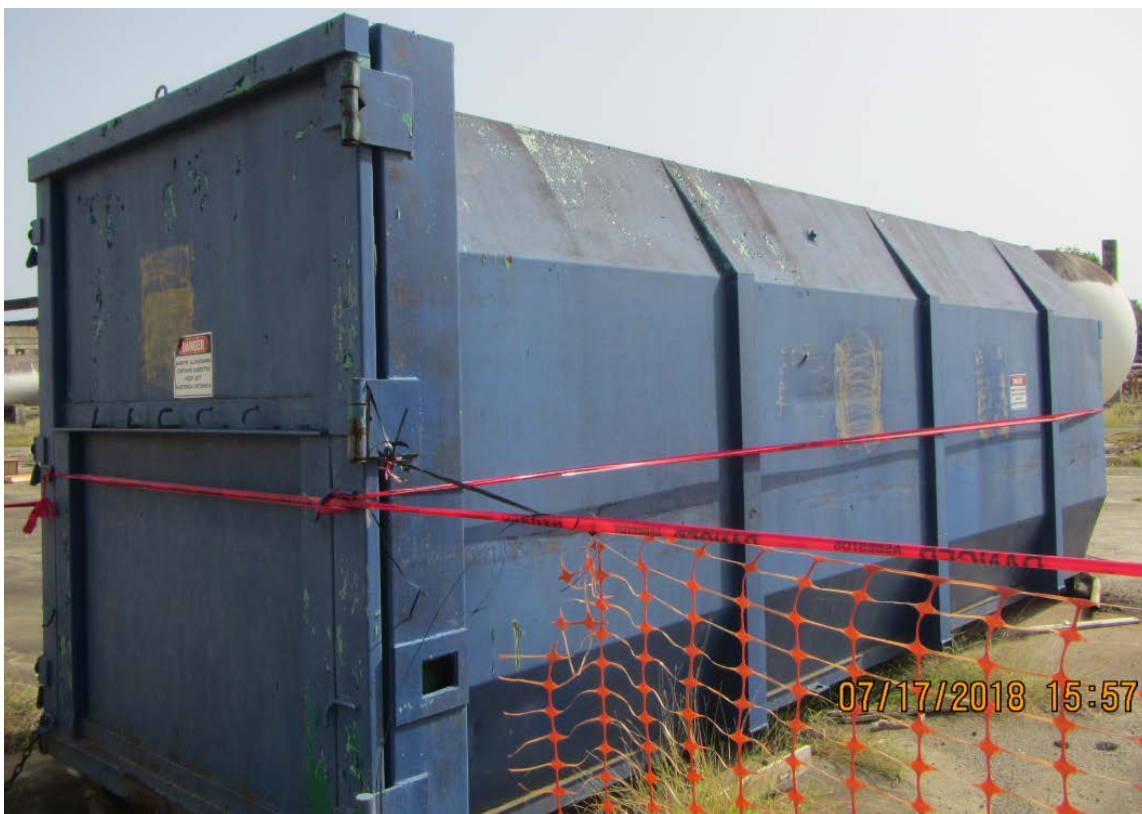
Figure 44, Container, approximately 20 cubic yard. According to Homeca staff, this is their first container since they started phase I work in accordance with the EPA approved workplan.

Two containers were found at the site. One of the container was an enclosed container that requires to be pried open with a metal rod (see figure 44). This container contained bags that appeared to be properly labeled and secured with duct tape. The second container contained some debris which included some aluminum claddings, a piece of metal pipe, some rubber tubes, and a plastic bucket (see figure 46). Homeca stated that they were planning to line this container with 6 mil poly-sheets and use it for debris that will not be bagged.

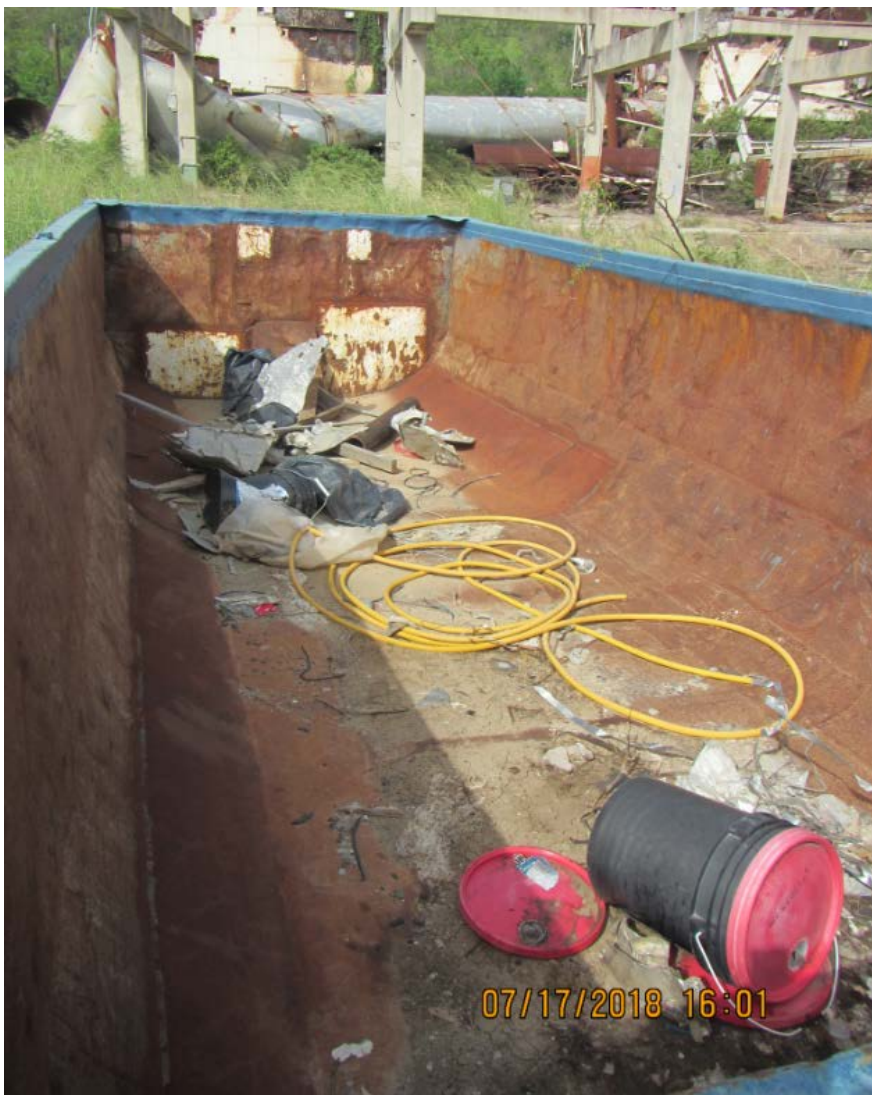
Figure 46, Inside of the second container on site. Homeca staff stated that this container will be lined with poly and used for debris disposal.
